Quality Alert

**MORGAN
SINDALL**
CONSTRUCTION

Defective Inspection Chamber—Wigan Pool

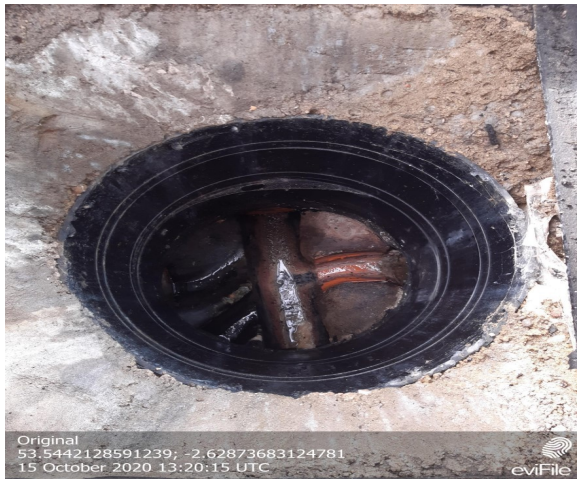
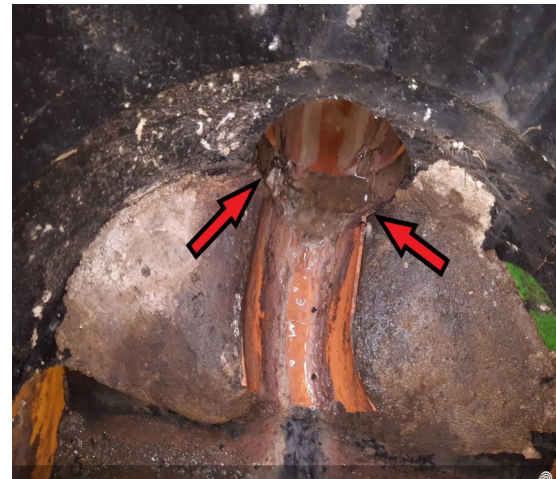
We received a defect regarding a blockage in a drain at Wigan which caused the internal foul pipe in the basement to burst.

The cause of the blockage was a 100mm DIA benched pipe was set against the flow direction of the main foul and not fully connected to the 150mm internal pipe. (see arrows below) This caused any debris to snag on the reduced sides as shown by the arrows in the first photo and over time cause a blockage that led to the pipe work in the basement to burst and spill foul waste within the building and over swimming pool equipment and building plant.
